Detectors & Mechanical W.J. Llope US DOE review of STAR TOF BNL, August 11-12, 2008

Outline:

- First delivery & WAH test stand
- Gas system
- Water systemInstallation procedure & fixture
- Start detector

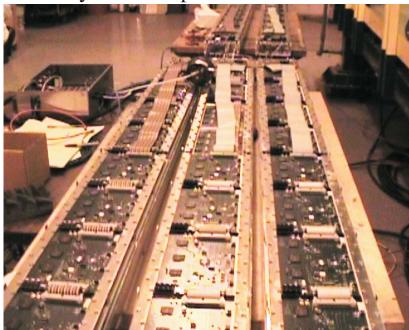
Before Run-8

5 trays
3 large tables
all facilities from platform
temporary gas runs from NE corner
trays tested open

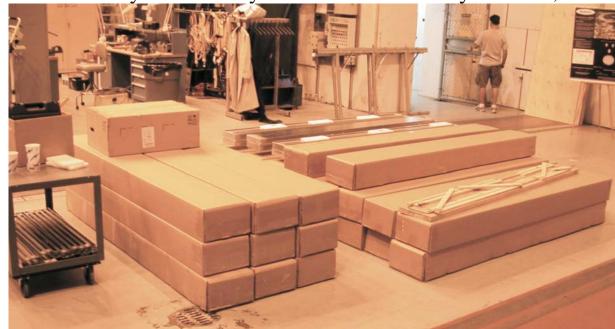
First delivery of final trays to WAH on Monday June 30, 2008

Test Stand Reassembled trays upacked & installed connected to gas system and HV system by Thursday July 3, 2008

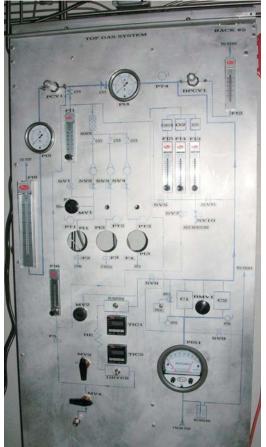
main control panel

Gas System

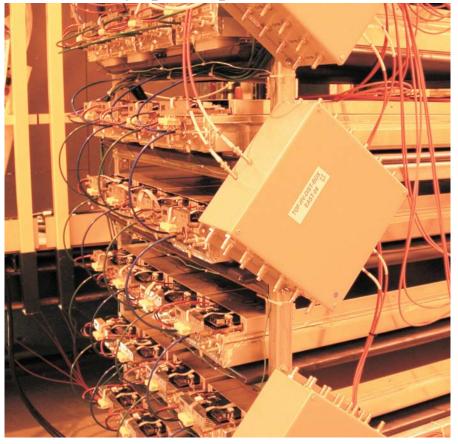
east distribution

west distribution

six supply-return loops to teststand 5 trays per loop

Quite some growing pains getting used to full gas system & dist. panels

Not yet recirculating gas a return line needs to be cleaned planned October 2008 Test Stand Results (HV Stability, HV current draw, noise rates)

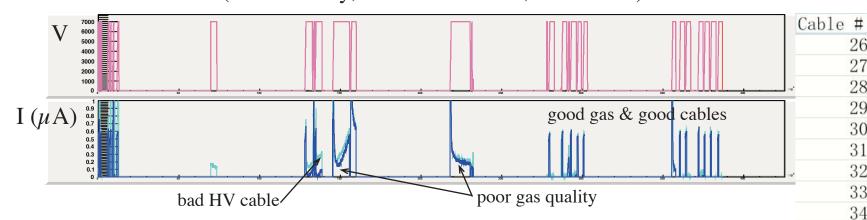
Significant leakage current from some HV cables! Also increases "noise rates" for MRPCs close to HV feed-throughs!

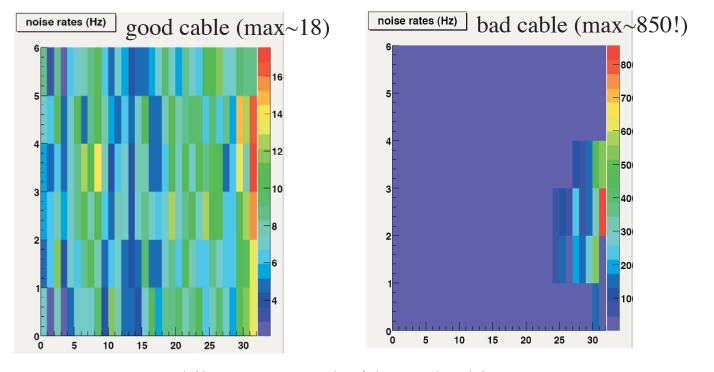
All trays ramped with good cables.

All noise rates < 50Hz once gas quality improved One new dead channel

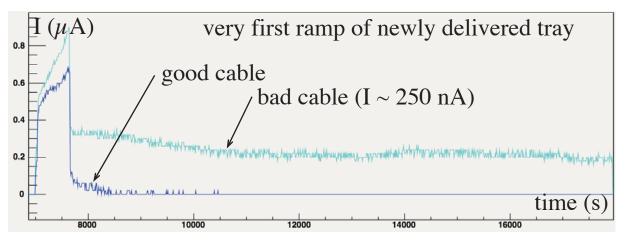
Three separate fabrication batches at KC Electronics

Batch 1: 30 @ 20' Batch 2: 80 @ 25' Batch 3: 150 @ 30'

10 @ 20' used in Run-8...

Leakage current test results in the last few days:

- 110 of the 30'
- 20 of the 20'
- 9 hour test of some of the "worst" 30' cables

- Different success rates for 30' cables by "box" suggested chronological correlation at KC
- All of the tested 20' cables have I<0.02 uA (...O.K...)
- Longer term test shows that 30' cables with I<1 uA will "burn in" over 4-6 hrs to I<0.02 uA.
- Representative from KC electronics to visit the site on Wednesday this week.

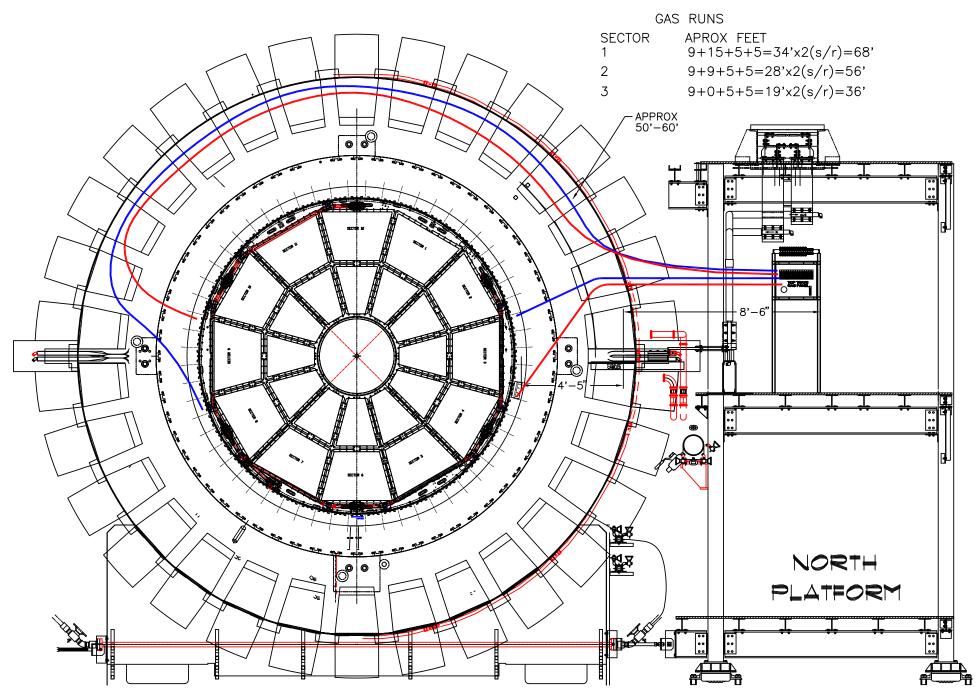
Z:\Dwgs\TOF\TOF-TRAY-GAS-RUN-Llope.dwg, 8/5/2008 4:08:49 PM

Gas distribution runs defined (J. Scheblein STSG), total tubing = 3000 feet.

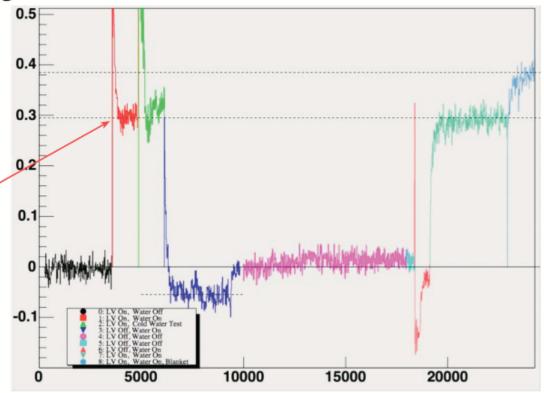
Power tests of TOFr5
140W total
square loop + shims
perforated tray cover

water $T_{input} \sim 31 \text{ deg C}$ flow rate $\sim 1.36 \text{ Gpm}$ water $\Delta T \sim 0.295 \text{ deg C}$

P(water) ~ 105 W P(radiative) ~ 35 W P(convective) < 1 W

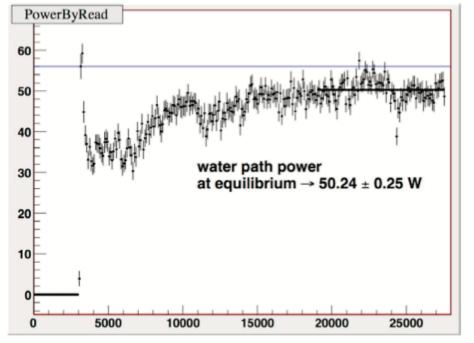
Power tests w/ early TDIG-Ds
55W total
rectangular loop + thinner shims
solid tray cover

water $T_{input} \sim 31 \text{ deg C}$

$\Delta T \sim 0.07 \deg C$

P(water) $\sim 50 \text{ W}$

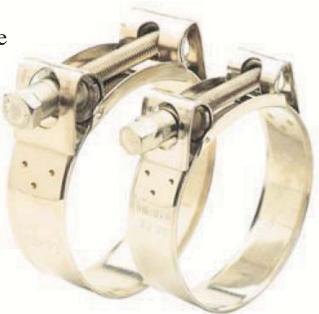
Bridge Opening T-Bolt Hose Clamps

leaks occurred at connection of vinyl braided hose to Tray Cu loop barbs

Will use more expensive high-performance clamps from now on.

re-torque after 2 weeks

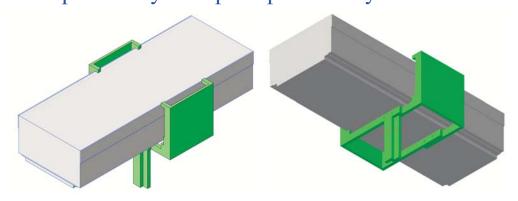
TPC Rail on spreader arm hung from crane
Rail bolted to magnet end-rings
Special tray clamps to protect tray skin

Choreography of insertion procedure, touch-points, etc, part of TOF+STSG discussion tomorrow morning

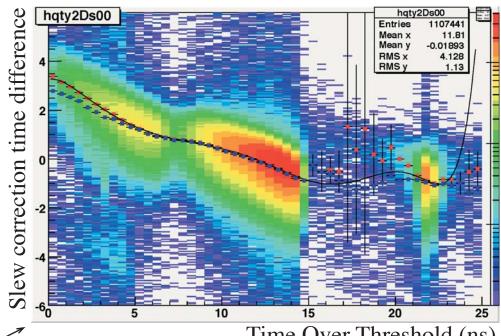
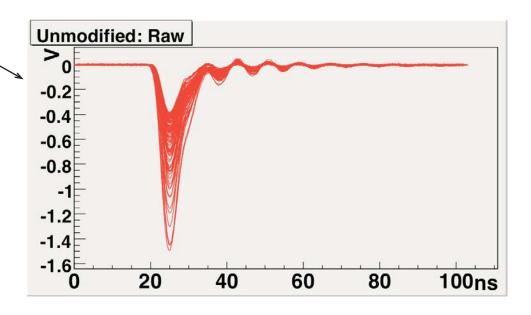
Time Over Threshold (ns)

Run-8 (d+Au, p+p, & 9 GeV Au+Au) again, an input to STAR trigger single detector $\sigma \sim 130-140$ ps in both p+p and d+Au

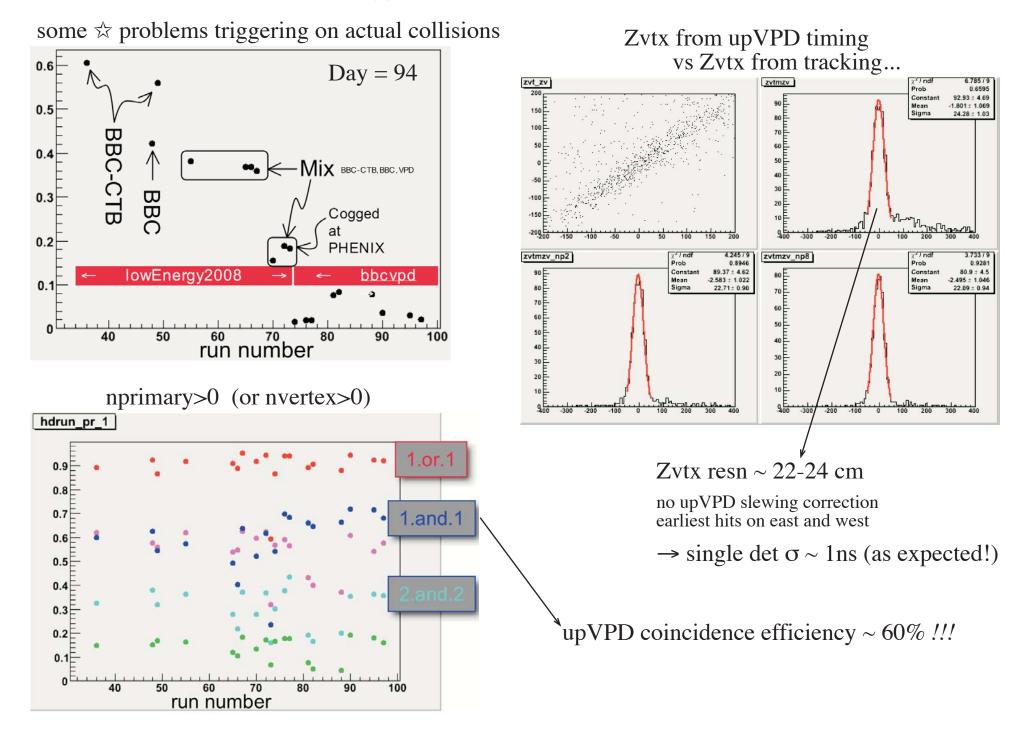
Start Detector in Low Energy Run-8 (9 GeV)

- Start detector is (somewhat surprisingly) highly-efficient (~60%) during the 9 GeV test run in Run-8 Start Detector base "ringing" now reduced via electronic modifications
